# Test Report

Report No.: HCT18CR-0211S-2

Sample Name: MUOD Series Outdoor UPS  
Sample Model: MUOD1K, MUOD2K, MUOD3K, MUOD6K, MUOD10K  
Amount of sample: 1pcs  
Sample Received Date: 2018/03/12  
Testing Period: 2018/04/23~2018/04/25

Test Sequence	Test Item
1	IP6X test
2	IPX5 test

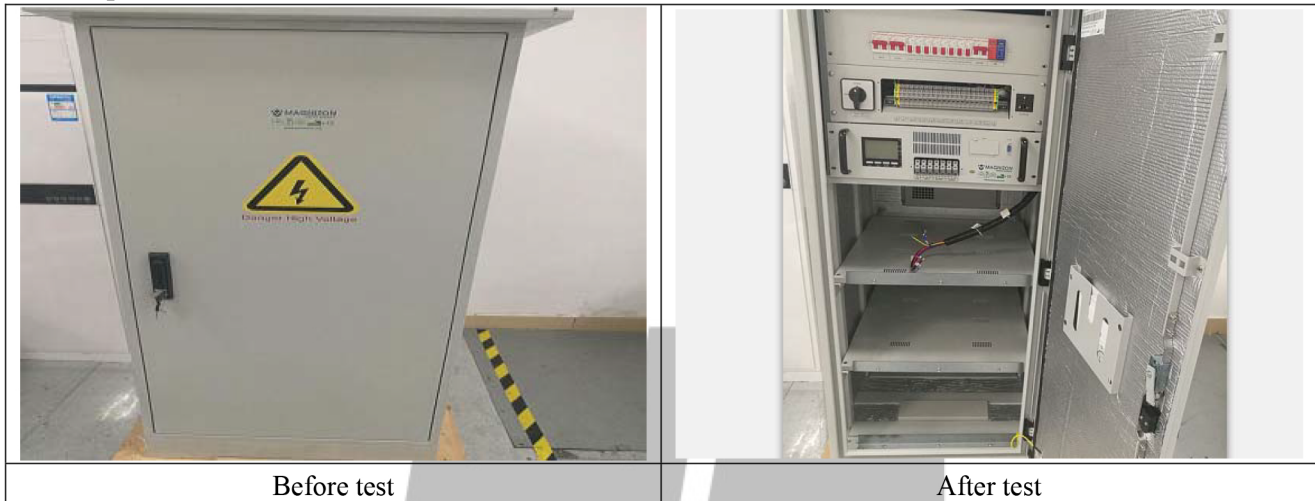
(7) Test photos

- 1) The Test prober of 1 mm diameter is pushed against any opening of the sample with force of 1 N
- 2) Set the sample in the dust chamber, the pressure inside the enclosure is maintained below the surrounding atmospheric pressure by a vacuum pump (Pump speed: 300 mL/min, less than 40 times of the shell volume per hour; the differential pressure between the containment and the atmosphere: 2 kPa)  
The talcum powder to be used is 2 kg/ m<sup>3</sup> of the test chamber volume;  
Test duration: 8 h

Sample No.	Sample name	Test Results (visual observation)
001	MUOD Series Outdoor UPS	Test prober can not penetrate into opening of the sample. No dust entered into the sample, the sample passed the IP6X test.

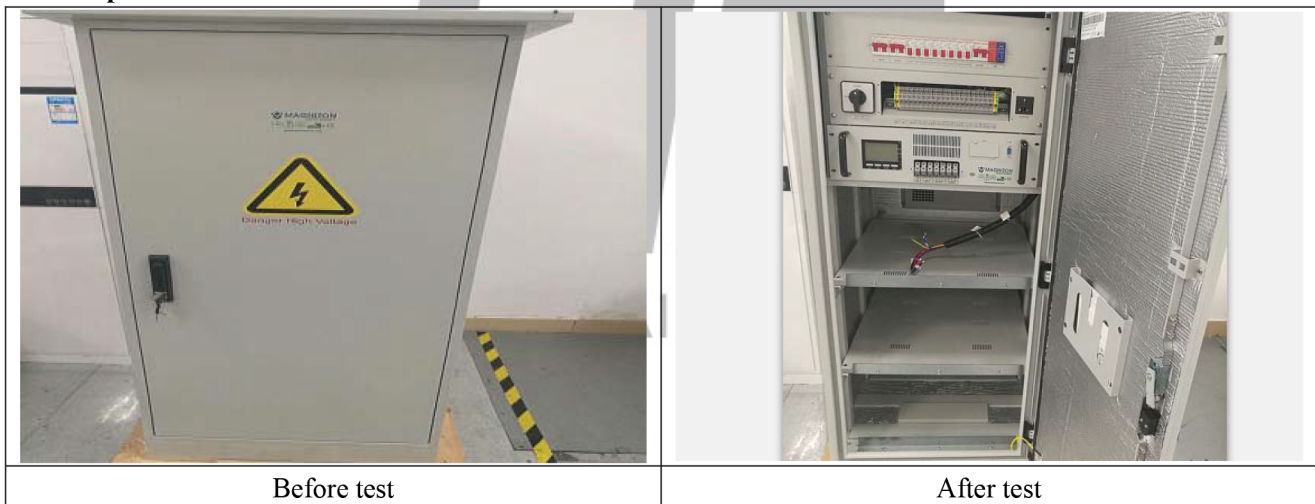
(7) Test photos

- 1) Water flow rate: 12.5L/min
- 2) The rotation speed of the turntable: 1rpm
- 3) Nozzle bore: 6.3mm
- 4) Distance the nozzle to sample: 2.5~3m
- 5) Test duration: 3 min

Sample No.	Sample name	Test Results (visual observation)
001	MUOD Series Outdoor UPS	No water entered into the sample, the sample passed the IPX5 test.

Before test

After test
